Unlocking Development at Belfast Harbour

Sewer Rehabilitation using
Trenchless Technology

12th March 2026

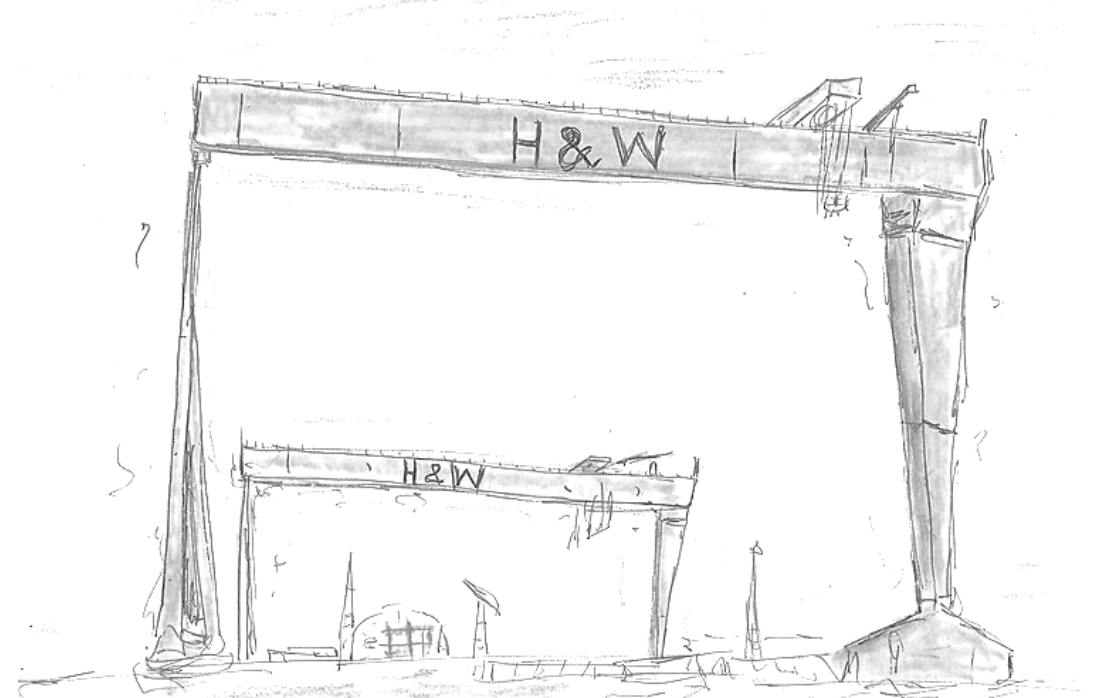
Specification

- Minimum design life of 60 years
- Groundwater loading

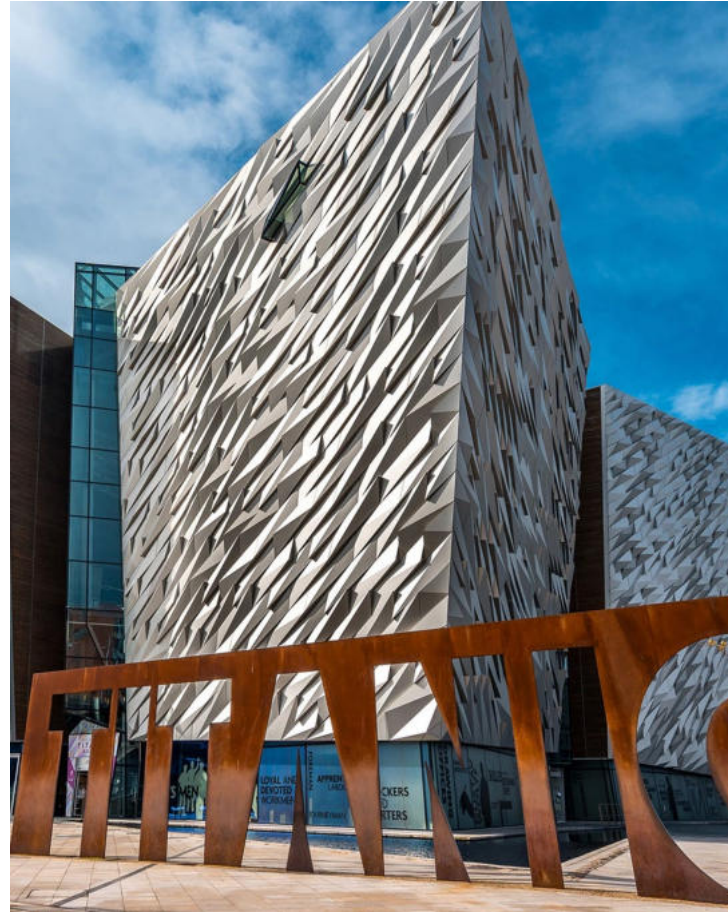
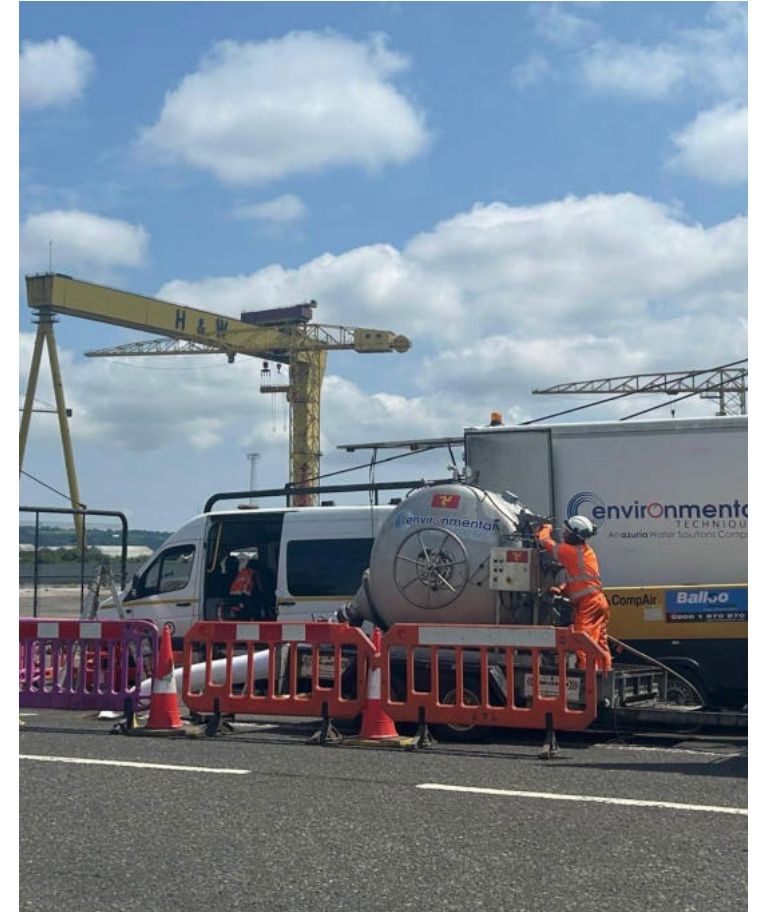
Why CIPP Lining?

Ageing Infrastructure beneath a Growing Harbour

- No excavation required
- Reduced infiltration
- Restored structural integrity
- Critical interfaces with operating businesses reducing stakeholder disruption
- Lower whole-life cost solution
- Minimal disruption to traffic and environment

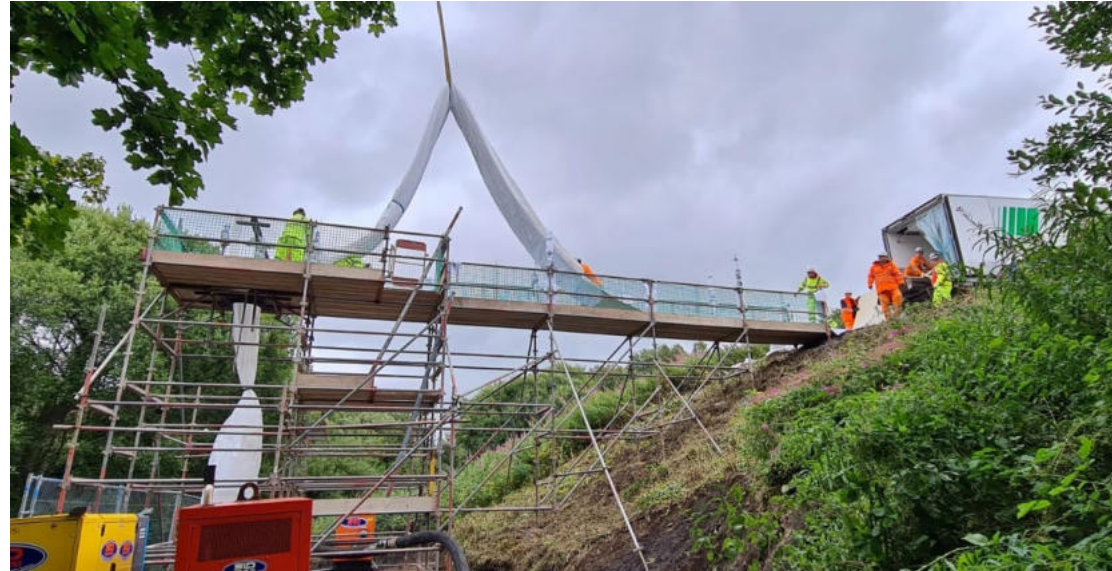
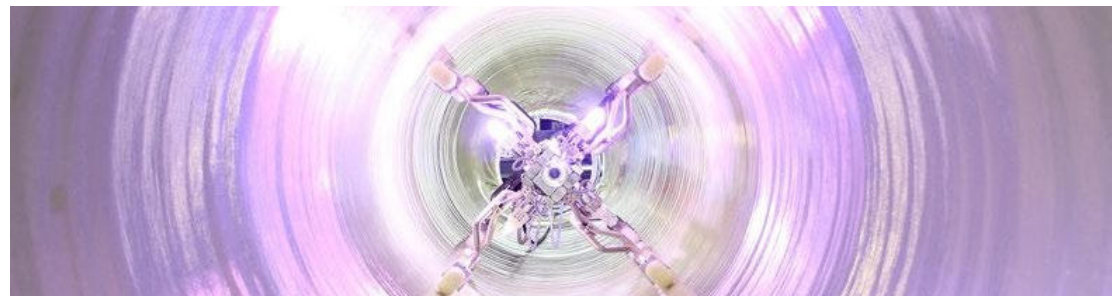
Option Selection

- **Hot Water Cure** – Traditional method for larger diameters
- **Steam Cure** – Faster heat-up and efficient for small diameters
- **UV Cure** – Controlled curing using light-activated resin

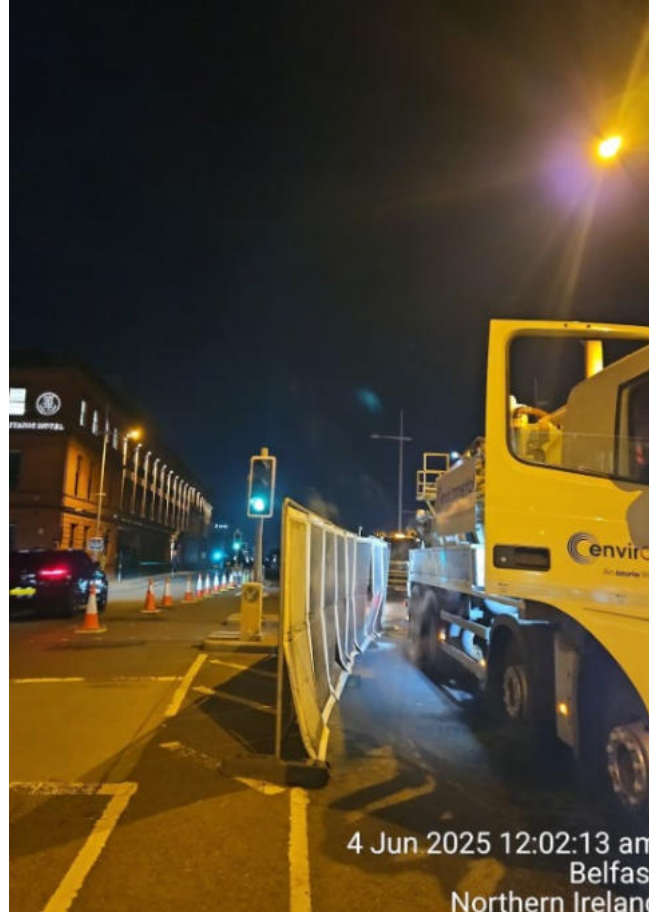
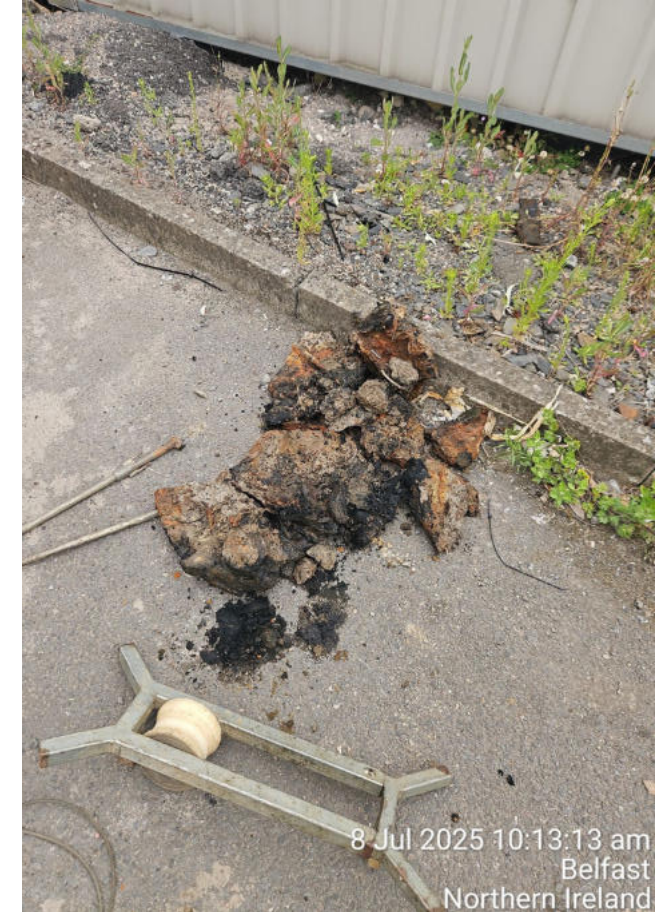
Lessons Learned

- Traffic Management incl. night working
- Early engagement with businesses e.g. hotels
- Fragility of network needs carefully managed
- Unexpected bitumen and bricks found in sewer
- Flexibility for added value – e.g. additional CCTV survey upstream network carried out
- Unexpected sewer diameters
- Avoid open cut where possible!

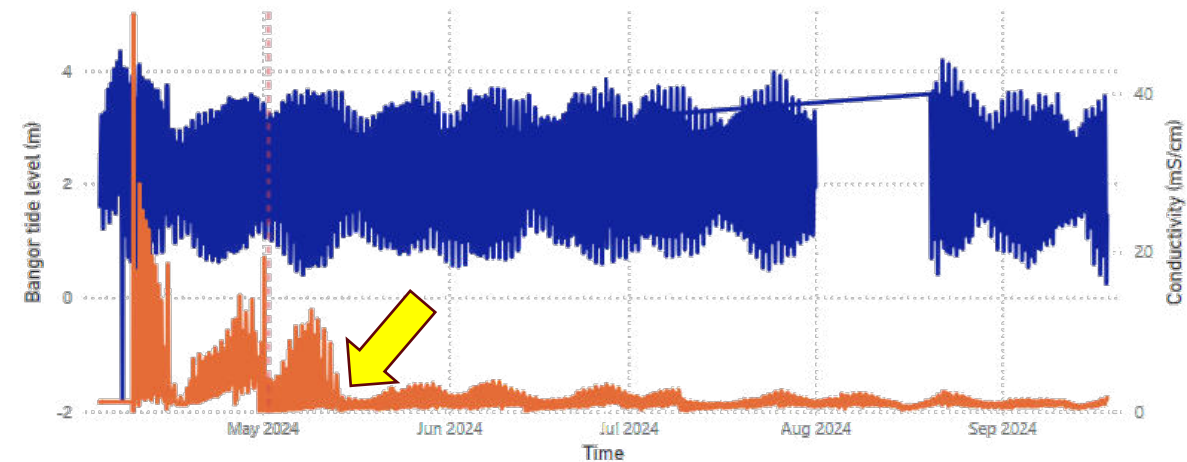
Bangor tide levels (mAOD) and Conductivity (mS/cm)

Tide data between 1-18 August is missing

● Bangor tide level (m) ● Bangor tide level (m) ● Conductivity (mS/cm)

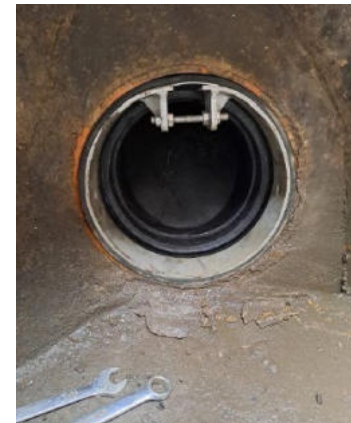
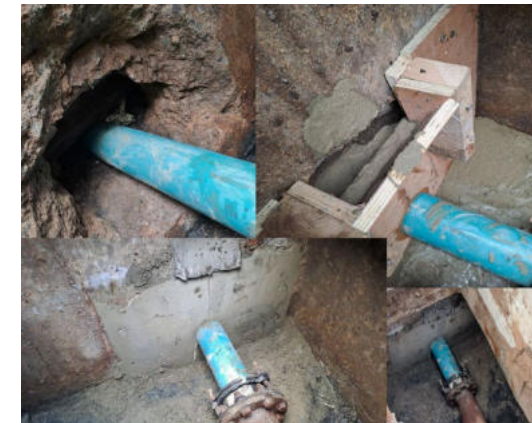
Salinity Reduction

- Client: Northern Ireland Water
- NIW & Arup in conjunction with GRAHAM & BlockBusters Environmental Services
- Total Investment of £110k
- Step change in salinity levels

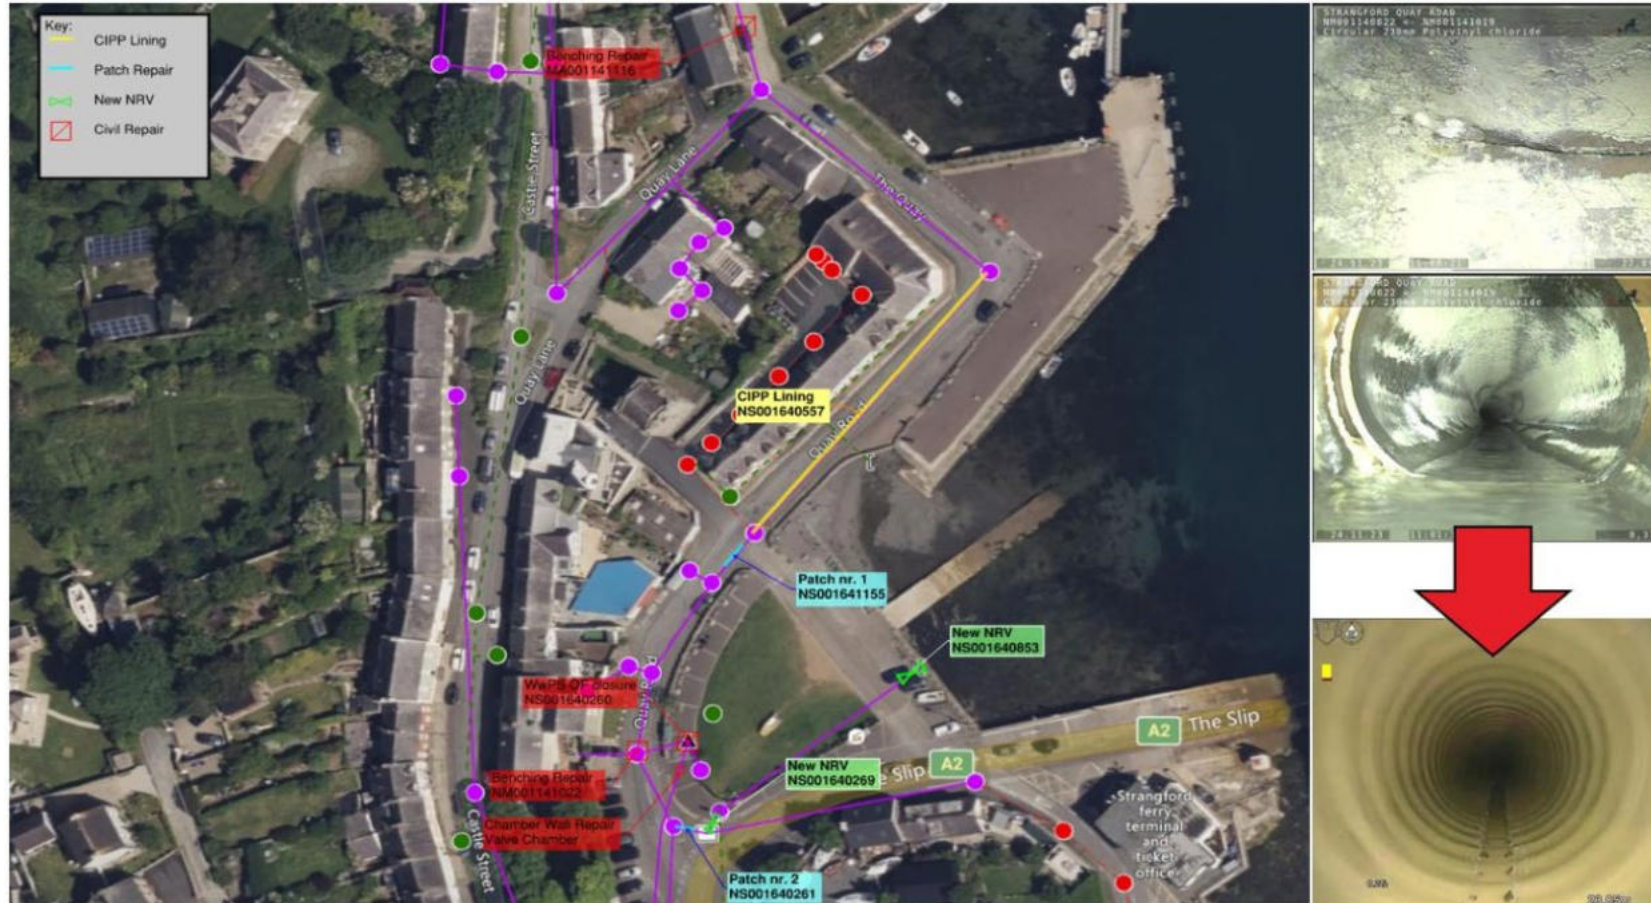
Types of the remedial work carried out (left) and Quay Road sewer before (top right) and after (bottom right) CIPP lining © Arup

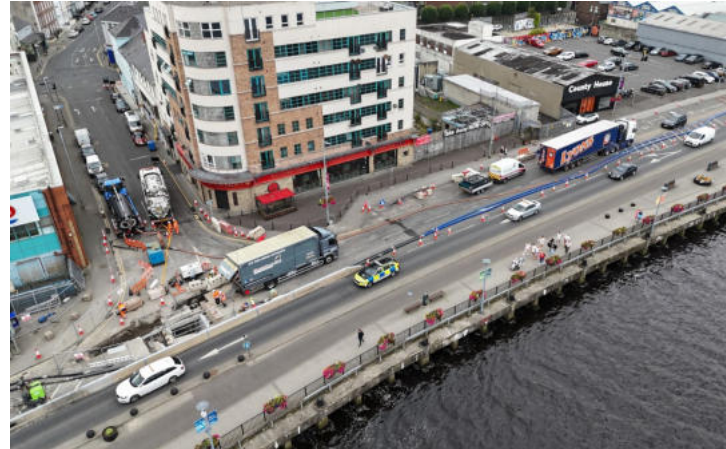
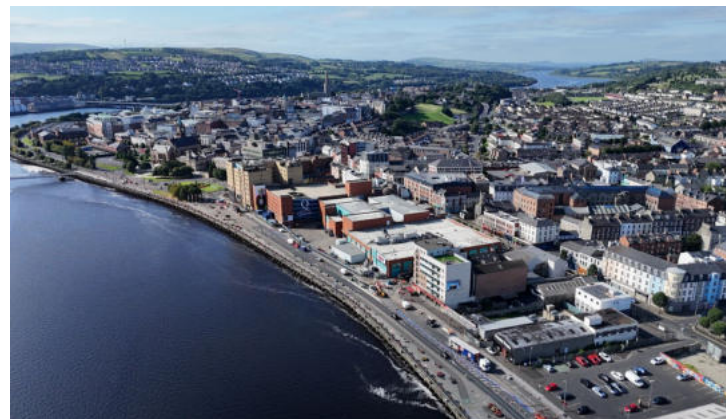
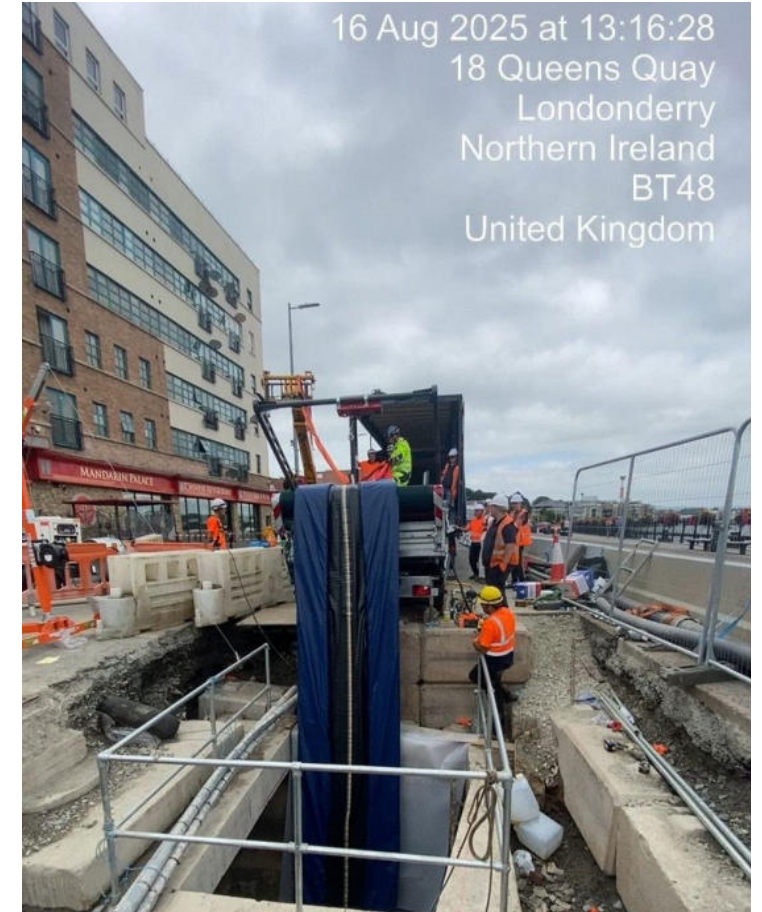
CIPP Liner Installation

- Client:
Northern Ireland Water
- NIW & Arup in conjunction with GRAHAM, BlockBusters Environmental Services and WaterWorX
- 186m length, 1350mm diameter CIPP liner - Work completed August 2025
- Using cutting-edge UV-cured technology
